## LONGEVITY OF DUCT TAPE IN RESIDENTIAL AIR DISTRIBUTION SYSTEMS: 1-D, 2-D, AND 3-D JOINTS

BASS ABUSHAKRA  
ASSISTANT PROFESSOR  
MILWAUKEE SCHOOL OF ENGINEERING  
MILWAUKEE, WISCONSIN

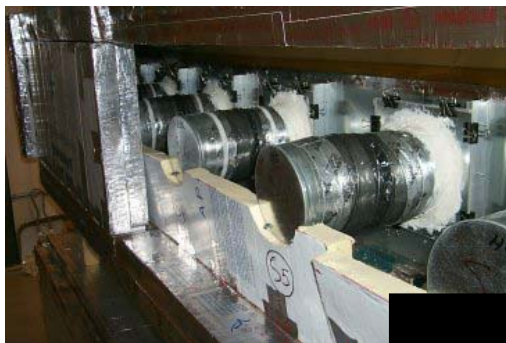
**Figure 1. One Chamber of the High Temperature Aging Test Apparatus**

Figure 1 shows samples mounted on the aging test apparatus. Heated air is continuously circulated through the test apparatus to both heat and pressurize the leakage sites. The apparatus is divided into an upper and lower chamber that each contains nine

samples. The inside of the test samples are exposed to high pressure heated air and the outside (shown in Figure 1) is in an insulated chamber that also becomes heated during the experiments by conduction through the test samples. This means that there is little temperature gradient across the samples. The hot air temperature is controlled using electric resistance heaters mounted directly in the air stream. The surface temperatures of each sample, the air temperature and the pressure across the leaks are

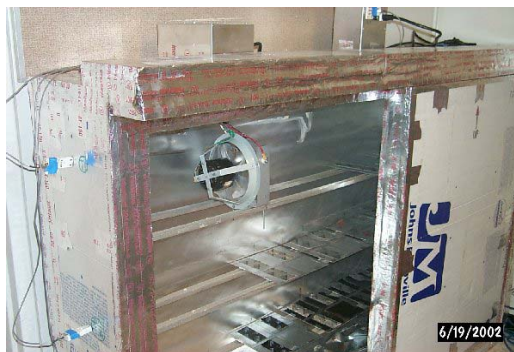
**Figure 3. The High Temperature Baking Apparatus**

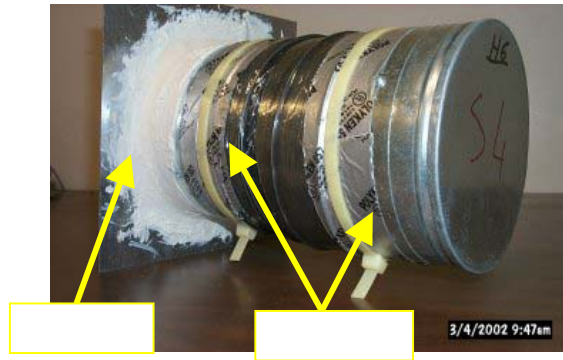
**Figure 5. Example of Test Sample Showing the Two Taped Connections and the Mechanical Clamps**

layers (one continuous piece) of duct tape applied to the core of the duct with the insulation and outer moisture barrier removed. The taped joint is reinforced with a mechanical plastic clamp installed over the tape as required for UL 181 B-FX installations. Figure 5 shows a laboratory construction of the 6" (150 mm) flexible core-to-collar joint aging test specimens, which contains two core-to-collar joints (the joint being tested) and one collar-to-plenum joint (not tested and sealed with mastic). The white irregular ring of material at the back (left) is mastic that has been applied over the collar-to-plenum joint. The end of the duct is capped with a metal cap that is sealed before testing. Figure 6 shows a schematic of the flexible duct core-to-collar joint as it fits on the aging test apparatus. Figure 6 shows how the whole specimen is enclosed in insulation that forms a test chamber.

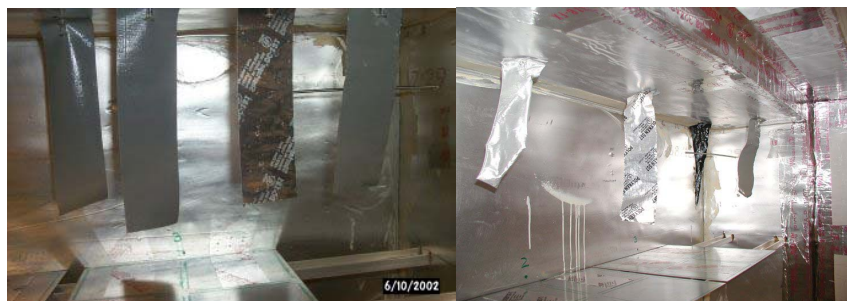
**Figure 8. Hanging Specimens of Tapes 1 to 4 in the High Temperature Baking Apparatus Before Testing and After Three Weeks of Testing**

Visual inspection of the baking specimens showed gradual deterioration in the specimens over the 60 days period of the test (as required by the UL standard), whereas specimens of the duct tape tested which were hung in the oven without being applied to any substrate showed considerable deterioration after only two weeks of baking. After the first week of baking, the specimens showed the following: (1) No significant deterioration among all specimens, (2) No noticeable shrinkage of the tape on the sheet metal substrates, (3) The Aluminum Foil and PET specimens tended to roll (curl), (4) The hanging specimens tended to "curl" as well, and (5) The Polyethylene specimens did not show any rolling; their surface in fact became "rougher" (the polyurethane used is a "woven film").

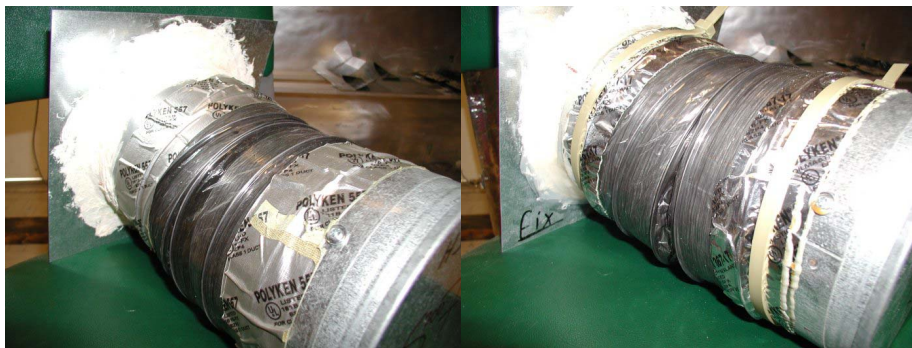
**Figure 9. (Left) Shrinkage and Delamination Among the Unclamped Specimens (Showing Here Result of 5 Months of Aging), and (Right) Oozing of the Adhesive Layer in the Foil-Butyl Tape (Tape 4) Specimens (Showing Result of 5 Months of Aging)**

- shrinkage and delamination among the unclamped specimens (Figure 9, Left)
- oozing of the adhesive layer in the foil-butyl tape (Tape 4) specimens (Figure 9, Right)
- little shrinkage and delamination in the strapped specimens
- discoloration of the plastic strapping in the clamped specimens
